Kidderpore Avenue, Hampstead

Bat Surveys

Report for Barratt West London

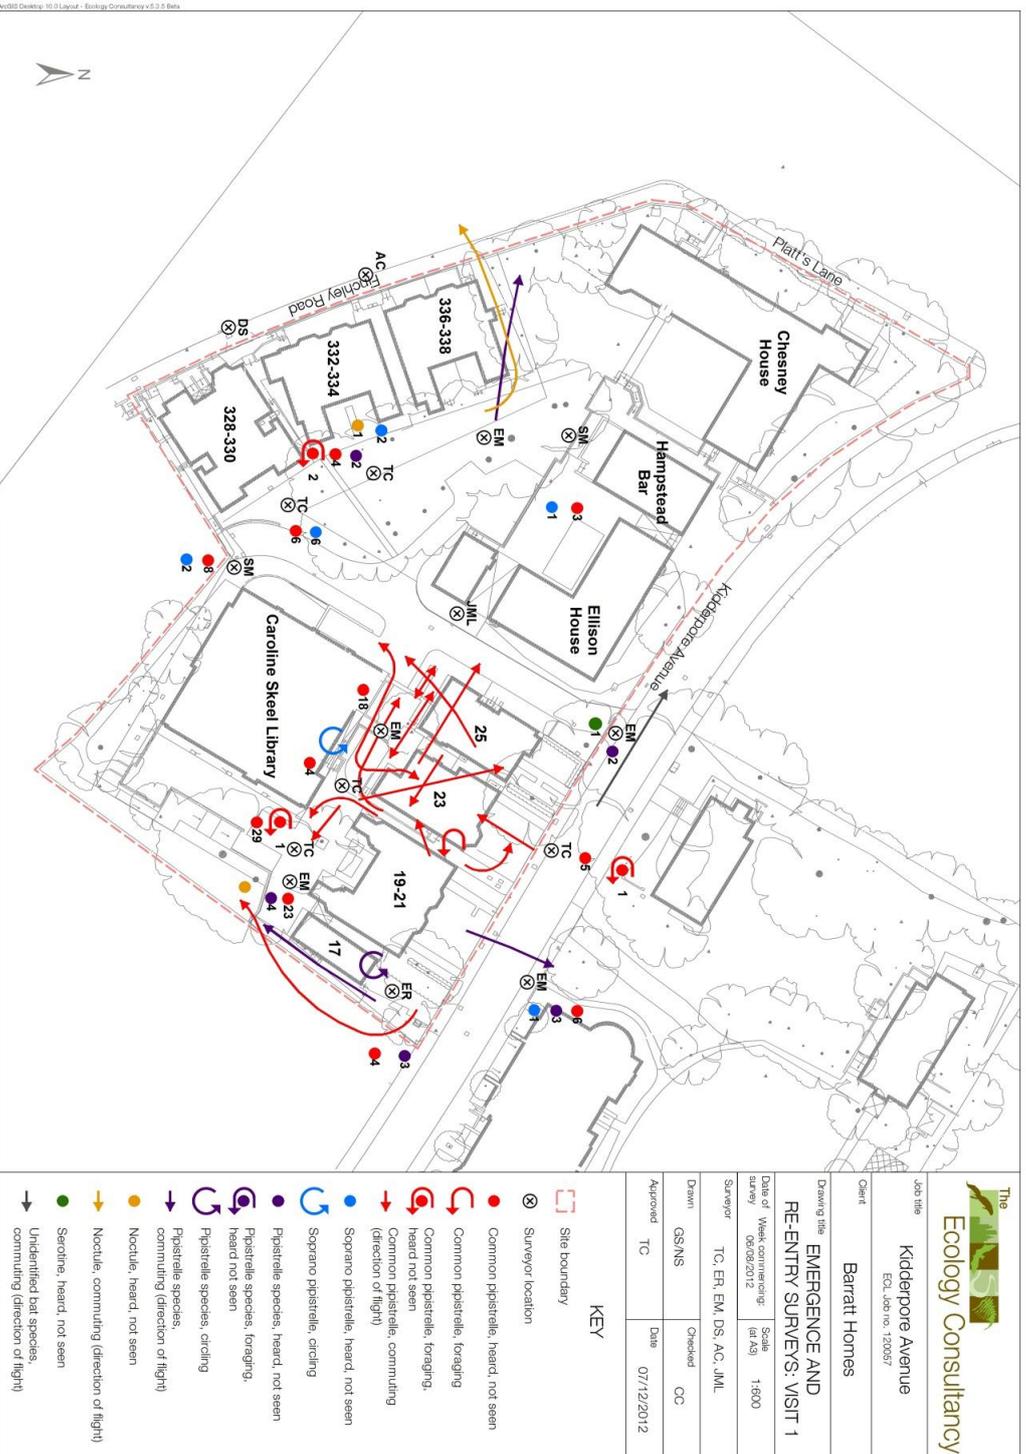
Plan 1: Bat Survey Plan, Kidderpore Avenue, Week Commencing 6th August 2012, Survey Parcel 1

- 3.5 Ecologists experienced in bat activity surveys were present for each survey. The surveyors were positioned around the buildings in such a way that all potential access/egress points were observed and, where possible, with a degree of overlap between the visual range of each surveyor in order to reduce the likelihood of bats being missed (see Appendix 1).

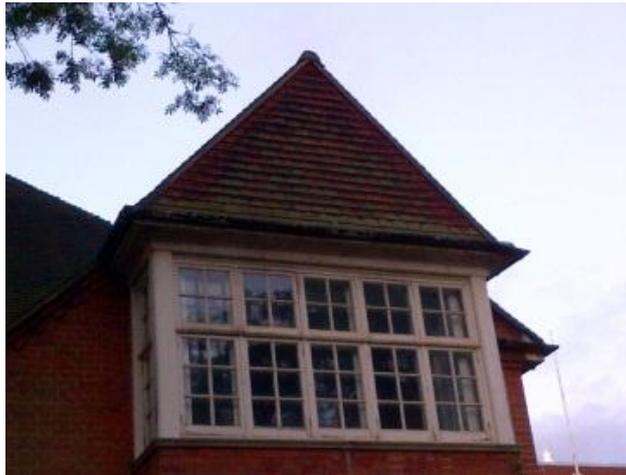
Photograph 1

- 4.3 A bat roost was recorded at 25 Kidderpore Avenue during the emergence survey on 28th August.
- 4.4 During this survey, one common pipistrelle bat was recorded emerging from under the hanging tiles on the top section of the double bay window, on the east elevation of the building at 20:38, 43 minutes after sunset (see Appendix 3, Photographs 1 and 3).

Hanging tiles on the top section of the double bay window on 25 Kidderpore Avenue. A common pipistrelle emerged from under one of the hanging tiles.

- 5.11 The roosts should be replaced / re-instated following renovations works and should be replaced with like for like materials to replicate the conditions of the existing roosts.

- 5.12 Where the existing hanging tiles are removed on the top section of the double bay window, following renovation, hanging tiles can be re-fitted to horizontal timber batons (20 – 25mm thick) on this elevation of the building with two to three tiles being adapted hanging tiles (see Bat Conservation Trust, 2012), which allows access for bats to roost beneath them. The location of these access tiles will correspond with the identified access / egress points observed in the survey. Behind the hanging tiles will be bitumen felt or a rough plywood.

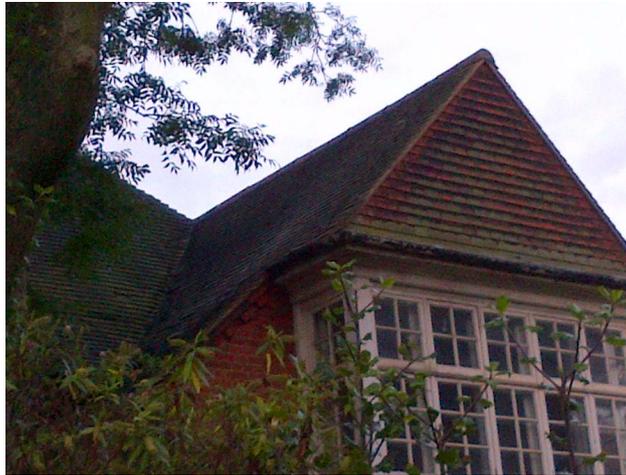
Photograph 2

- 4.5 During the same survey, two common pipistrelle bats were recorded re-entering the building under lifted or missing tiles on the southern pitch of the double bay window which was on the east elevation of the building (see Appendix 3, Photographs 2 and 3).

The southern pitch of the double bay window of 25 Kidderpore Avenue. Two common pipistrelle bats were seen to re-enter a section of the roof, likely to be under lifted and or missing tiles.

- 5.13 Where the roof tiles are to be replaced and the roof re-lined on 25 Kidderpore Avenue, traditional bitumen and hessian roofing felt must be used in preference to breathable membranes.

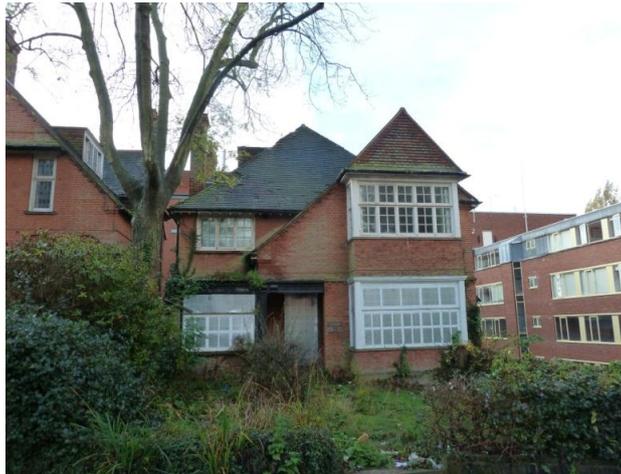
Photograph 3

View of the east elevation of 25 Kidderpore Avenue, showing the bay window where the above bat emergence / re-entry was observed.
